Manhole Inspection Summary

Manhole # S23K__063MH

Insp Date: **6/11/08 2:40 PM**

Location Address: **240 McHenry St**

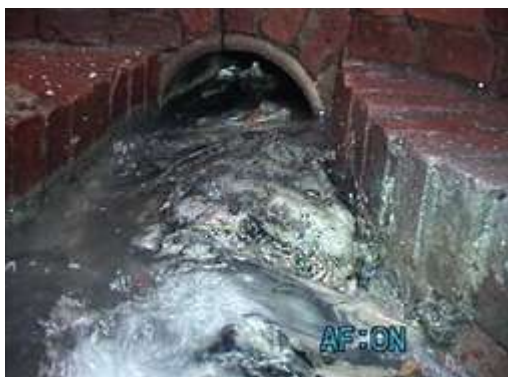
Misc

debris in channel and in 12 OClock pipe

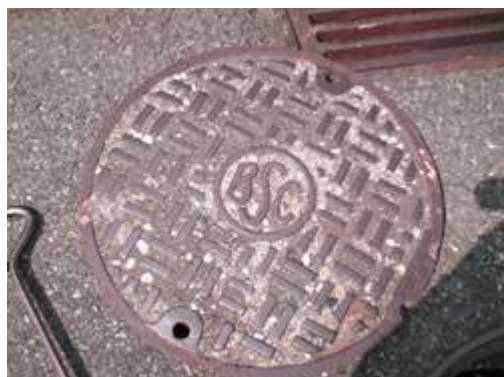
Misc

cover

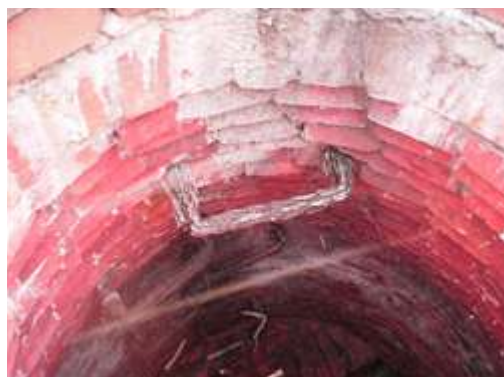
Defect 2

Count: **4** Missing: **0** ☒ **Corroded**

steps corroded

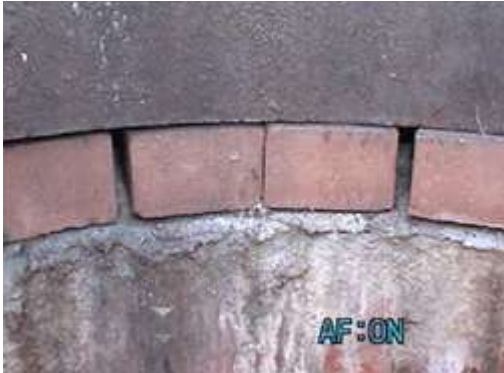
Defect 4

Condition: ☐ Sound ☐ Cracked ☐ Root Intrusion ☒ **Loose Brick** ☐ Deteriorated

chimney deteriorated

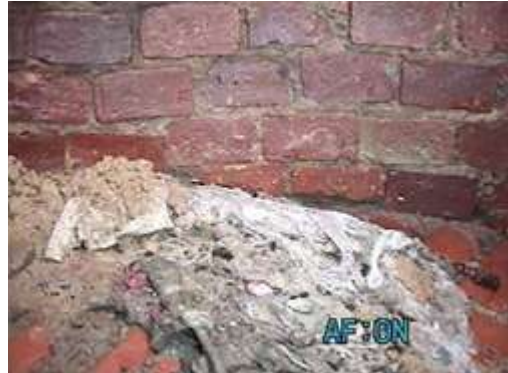
Defect 3

Condition: ☐ Sound ☐ Cracked ☐ Root Intrusion ☐ Deteriorated ☐ Leaks ☒ **Debris**

bench debris

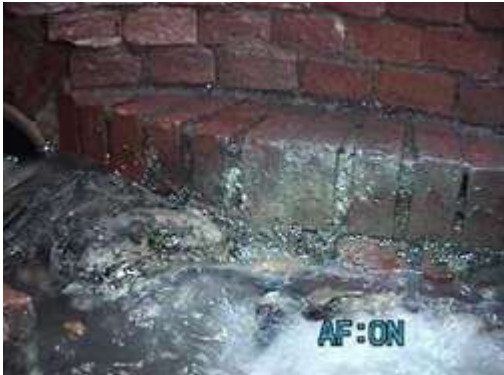
Defect 1

Condition: ☐ Sound ☐ Cracked ☐ Root Intrusion ☐ Deteriorated ☐ Leaks ☒ **Debris**

channel debris

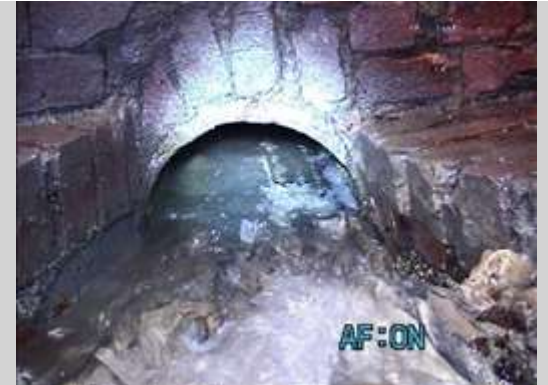
12 O'Clock Outflow

10 in. Circular Gravity Sewer
Pipe Out @ 12 O'Clock

Pipe Height: **9.6** (in.) Rod and Bar (Angled)
Pipe Material: **Clay** ☐ Pipe Lined
Invert Depth: **9.51** (ft.) Flow Characteristics: **Fast**
Deposits: ☐ None ☐ Mud ☐ Sludge ☒ **Debris** ☐ Grease
Silt Depth: **4** (in.) Deposits Extent: **Heavy**
Infiltration: **None** Pipe Seal Cond: **Sound**

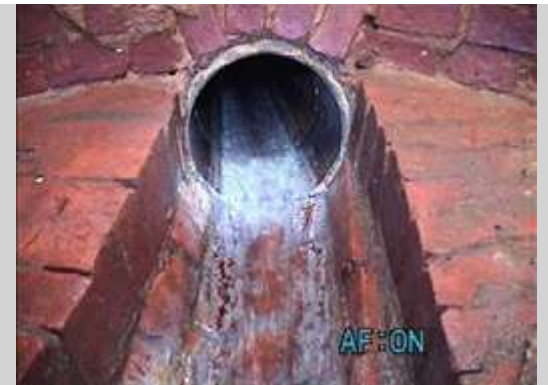
3 O'Clock Inflow

6 in. Circular Gravity Sewer
Pipe In @ 3 O'Clock

Pipe Height: **6** (in.) Rod and Bar (Angled)
Pipe Material: **Clay** ☐ Pipe Lined
Invert Depth: **8.67** (ft.) Flow Characteristics: **Fast**
Deposits: ☒ None ☐ Mud ☐ Sludge ☐ **Debris** ☐ Grease
Silt Depth: **0** (in.) Deposits Extent:
Infiltration: **None** Pipe Seal Cond: **Sound**

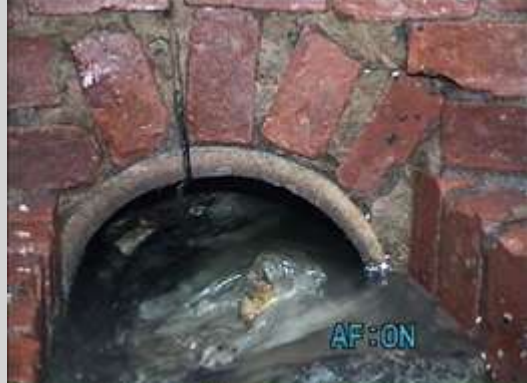
7 O'Clock Inflow

6 in. Circular Gravity Sewer
Pipe In @ 7 O'Clock

Deposits: ☐ None ☐ Mud ☐ Sludge ☒ **Debris** ☐ Grease

Silt Depth: **5** (in.) Deposits Extent: **Heavy**
